Headlight with fiber-optic xenon light source may cause harm to patients

Alberto J. de Armendi, MD, AM, MBA, Mohanad Shukry, MD*,
Pratistha Strong, MS, Jorge A. Cure, MD

Department of Anesthesiology, University of Oklahoma Health Sciences Center, Children's Hospital of Oklahoma, Oklahoma City, OK, USA

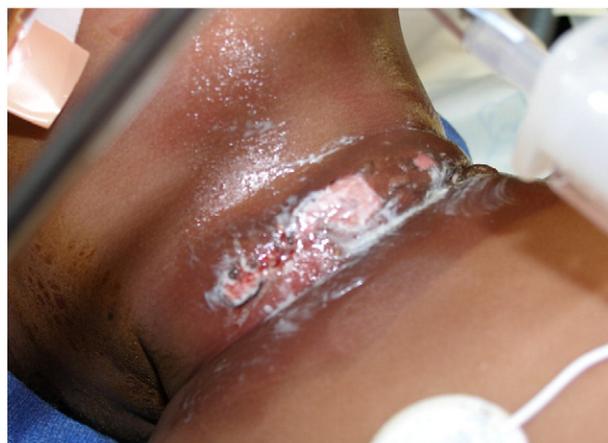
A burn on the neck was noticed on a child at the end of the procedure. The child underwent neck surgery with general anesthesia. The burn was diagnosed as first and second degree just around the incision where surgical drapes were not covering the child's skin (Figs. 1 and 2). The area was the site of the surgery where the light source was beaming on. The BFW, model 3010, Maxenon (QED, Lexington, KY) headlight with fiber-optic xenon light source was taken out of service immediately and sent to a nonbiased third party for full testing and evaluation.

Fig. 1. Skin burns on the neck.

Results from the nonbiased third party evaluation showed that the electrical safety was in accordance with all applicable state and national codes and regulations. No mechanical or functional problems were found. However, an aspect of the machine operation was found that could be responsible for the patient burn incident. Using a digital infrared thermometer, temperature radiation with lens aperture fully opened and fully closed at distances were tested (Table 1). Based on thermal data, open apertures (ie, maximum light intensity) with the lens at 15.2 cm and 30.5 cm away from skin had the potential to produce burns with temperatures greater than 73.7°C; small aperture settings (ie, lower light intensity) had little or no potential for causing skin damage at any distance from the lens with temperatures less than 28.3°C. For exposure times greater than 30 seconds, at 15.2 cm, and

We encourage physicians who use the BFW, model 3010, Maxenon (QED, Lexington, KY) headlight with fiber-optic xenon light source to become familiar with the manufacturer's recommendations and user's manual and to attend the company's in-service training demonstration. Since reporting our case to the company, BFW has updated the user manual by recommending a safe distance of 40.6 cm.

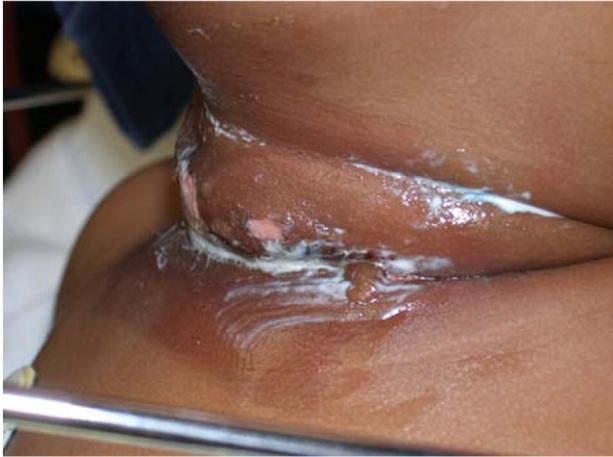
Fig. 2. Skin burns on the neck.
